**GOVE DIKE  
NH 00135**

**STATE NO 184.03**

**PHASE I INSPECTION REPORT  
NATIONAL DAM INSPECTION PROGRAM**

**JULY 1978**

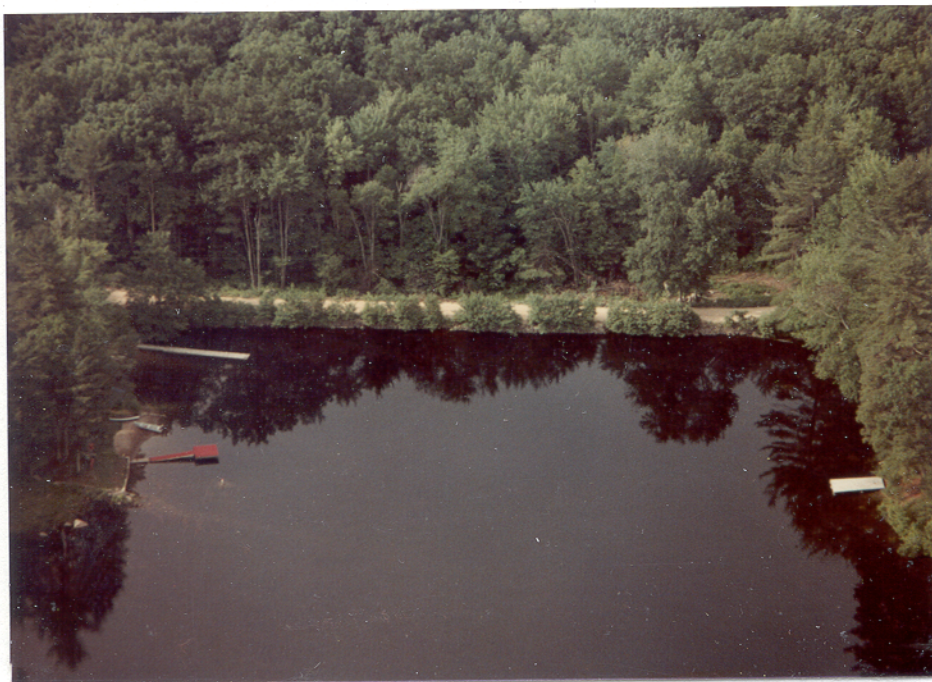
Figure 1 - Overview of upstream face of Gove Dike.

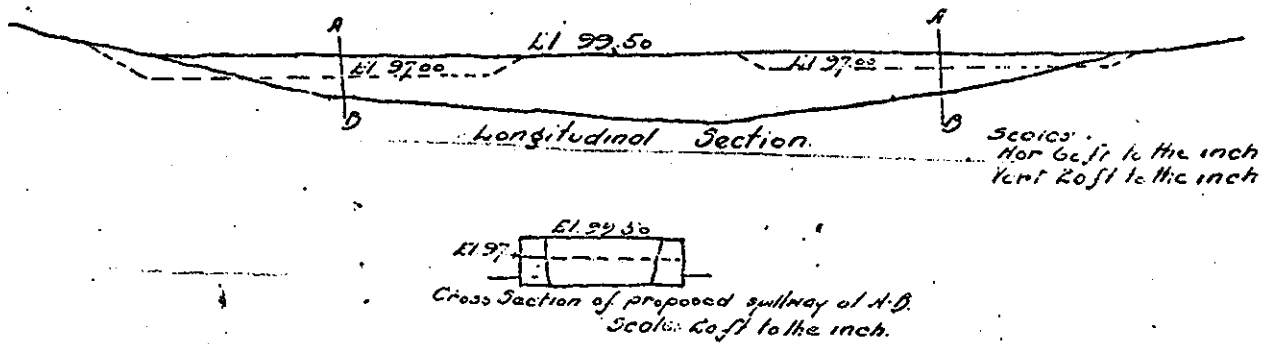
Fig. 1.

Changes to be made of Gore Dam (No 3)

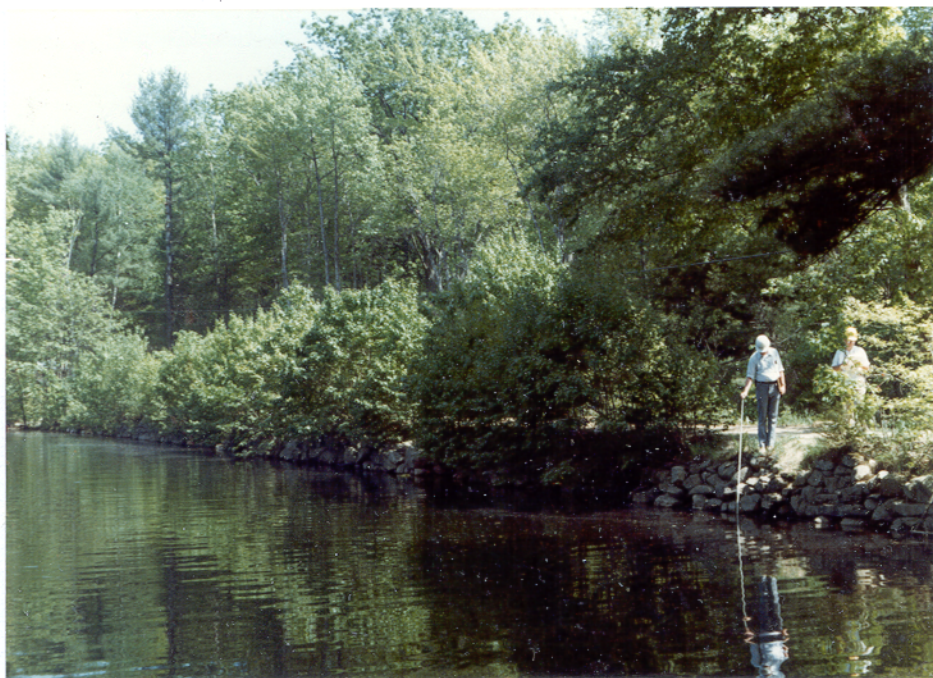
Figure 2 - Looking at the upstream face of the dike from the west bank of the reservoir.

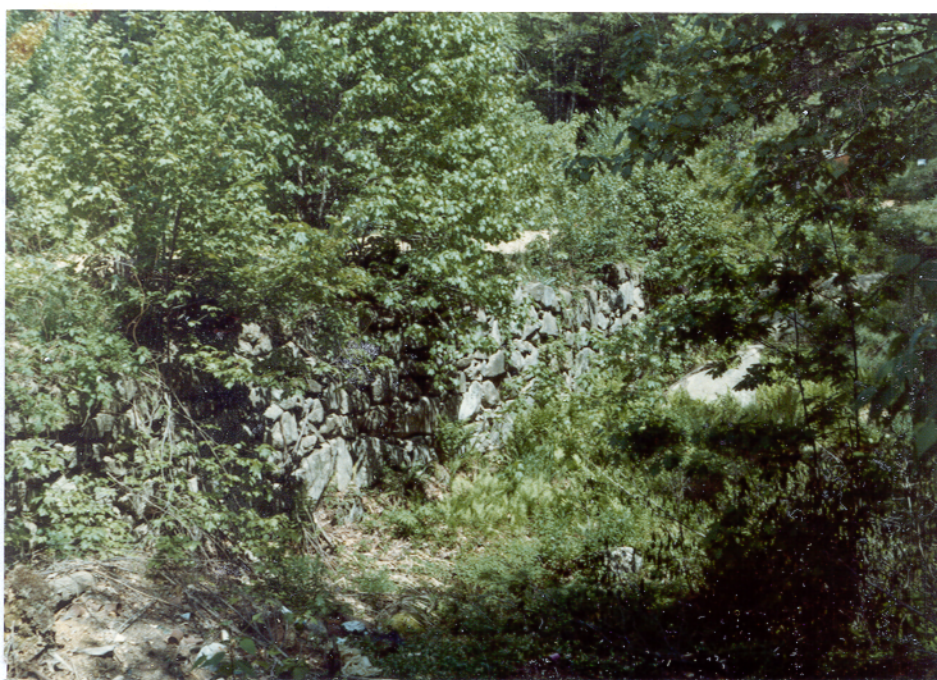
Approximately 100 feet from the left abutment, a bulge was observed in the downstream dry masonry wall. The wall is bulged approximately 6 inches at a height of 4 to 5 feet above the ground level.

Figure 3 - View taken from the west abutment looking east at the downstream face.

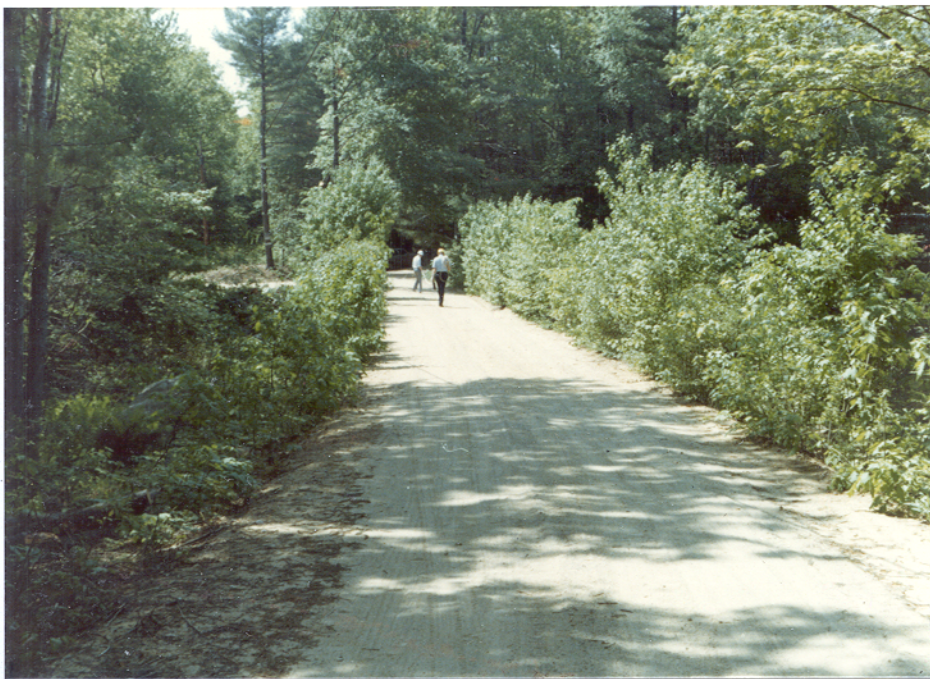
Figure 4 - Looking west along the center of the dike from the east abutment.

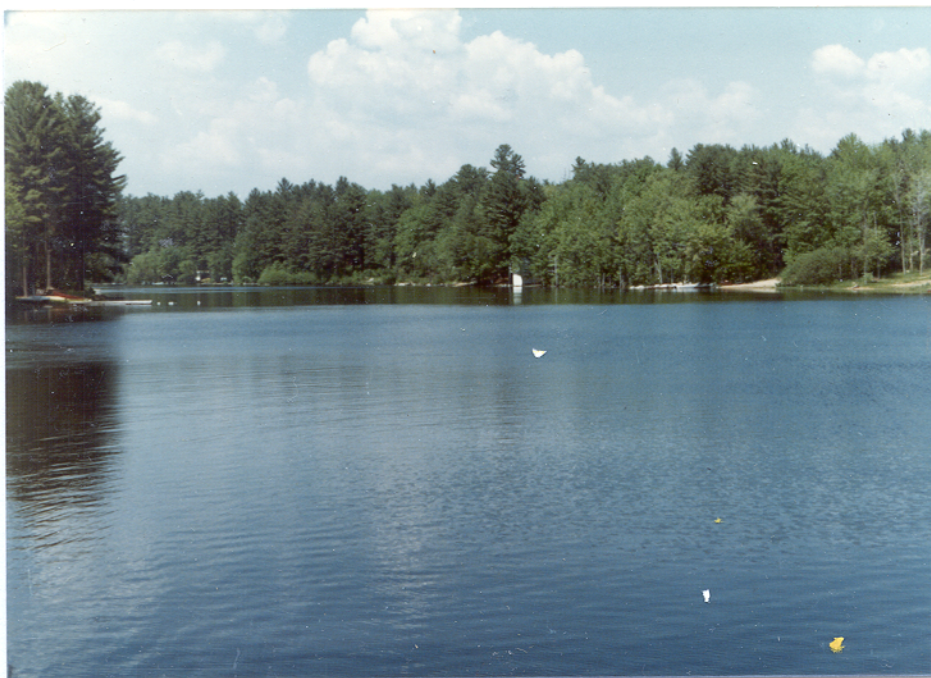
Figure 5 - View looking upstream at Pawtuck-away Pond from the center of the dike.

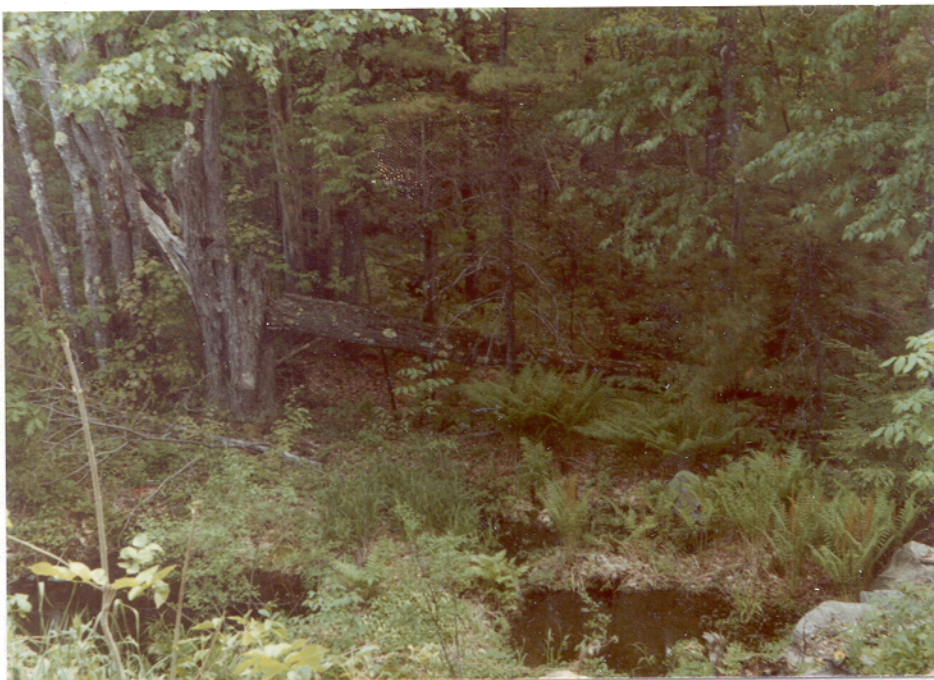
Two seepages were observed. One is estimated at .02 cfs (10 gpm) about 15 feet downstream of the wall near the center of the valley. The second, near the right abutment, has a barely visible flow. Discharge water from both seepages is clear. Standing water is visible approximately 20 feet downstream of the downstream face near the right abutment. Some fill has apparently been placed against the downstream face at the right abutment and filled to approximately the height of the roadway.

Figure 6 - Looking at the downstream valley  
from the top of the dike.
